THE EXPERTS IN INK TRANSFER TECHNOLOGIES

DAETWYLER FINDS A NEARLY \$1 MILLION SAVINGS

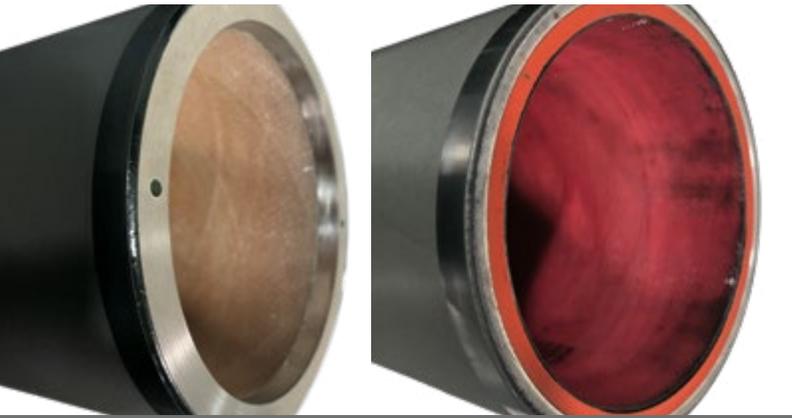
Sandon Sleeve

Competitor Sleeve (exposed ends)

- Sandon Global anilox rollers have bonded acrylic seals on the ends as well as solid, threaded end rings to minimize exposure of anilox ends and keep out caustic chemicals. The radius edge design also helps avoid chipping and similar damage.

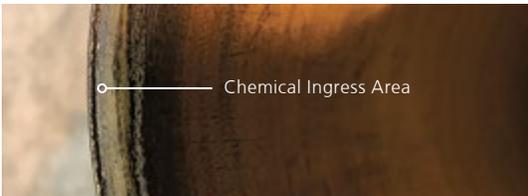
All of the damaged anilox rollers suffered from the same problem: Damaged Ends

- Unprotected ends allowed caustic cleaning chemicals to penetrate the roller interior over time.
- These chemical residues caused fractures and splintering between the layers of the anilox.

- As tiny fractures grow, small fragments of the anilox chip off the surface.
- Chipped fragments typically end up getting picked up during the inking process, then get stuck on the edges of doctor blades.
- The hard, sharp chipped piece gets pressed against the anilox, causing scoring.

Severe Score Lines

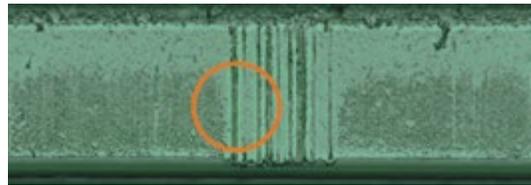
- Doctor blades are also damaged by the hardened chipped pieces, creating problems with inconsistent lay down as well as ink leakage near the end seals.

Damage to doctor blade from ceramic particles

Damage to doctor blades from chipped ends

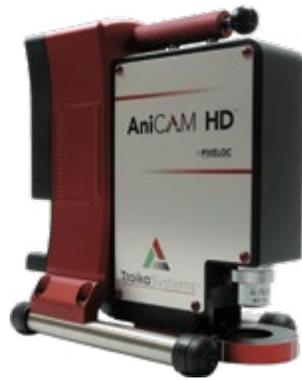
Anicam HD

- LaserClean is a chemical-free process that thoroughly removes inks, adhesives, and other residues, without exposure to liquids that could penetrate anilox ends.
- AniCAM HD is a microscopic hand-held tool that can identify potential end damage before chips start occurring, and can also identify even tiny score marks that may be impacting print quality.
- Filtration on the ink system can remove foreign particles before they get trapped against doctor blades or anilox and cause damage.
- An in-person or remote training session can demonstrate proper anilox handling methods to prevent damage from multiple sources.
- Regular anilox audits and quality checks can catch anilox problems when repairs are still possible, rather than waiting for catastrophic failures.
