THE EXPERTS IN INK TRANSFER TECHNOLOGIES

DAETWYLER FINDS A NEARLY \$1 MILLION SAVINGS

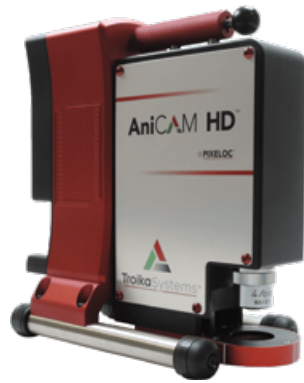
Anicam HD

- LaserClean is a chemical-free process that thoroughly removes inks, adhesives, and other residues, without exposure to liquids that could penetrate anilox ends.
- AniCAM HD is a microscopic hand-held tool that can identify potential end damage before chips start occurring, and can also identify even tiny score marks that may be impacting print quality.
- Filtration on the ink system can remove foreign particles before they get trapped against doctor blades or anilox and cause damage.
- An in-person or remote training session can demonstrate proper anilox handling methods to prevent damage from multiple sources.
- Regular anilox audits and quality checks can catch anilox problems when repairs are still possible, rather than waiting for catastrophic failures.
