CLEANING UP A LEAKY CHAMBER MESS

A DAETWYLER ANALYZE, DESIGN, IMPLEMENT, MEASURE
SUCCESS STORY

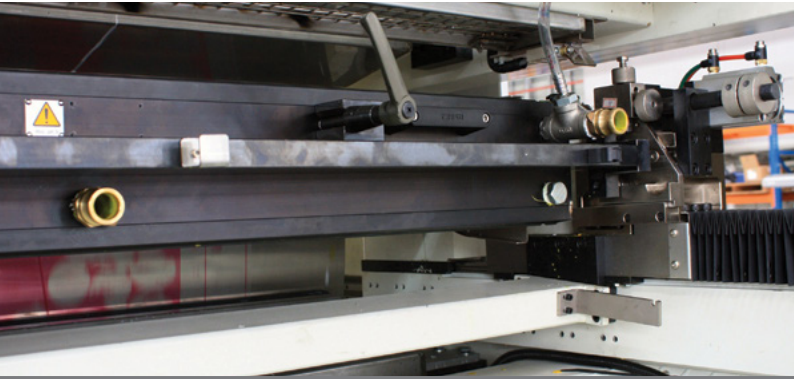
BEFORE DAETWYLER

Any way you look at it, a leaking chamber is a mess. Besides the physical mess of spilled inks, dirty presses, and time-consuming clean-up, there is the business disaster of wasted resources, the expense of downtime, and unacceptable print quality.

At a flexo print operation focused on flexible packaging for the food & beverage industry, leaking chambers and limited blade life were becoming all-too-common problems with their current doctor blade supplier.

After doing a thorough press evaluation, we agreed that we could provide more reliable doctor blades that offered better performance, but Daetwyler also recommended changes during set-up to better seal the chamber, including upgraded end seals and some foam tape applied to the doctor blade to fully address the problem.

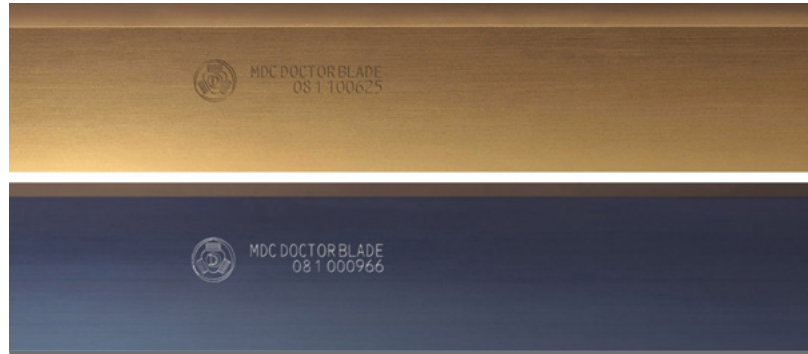
AFTER DAETWYLER

The client's management team agreed to a trial period using our complete set up of Daetwyler doctor blades, end seals, and foam tape to resolve chamber leaking. The results showed improvements immediately.

- Significantly reduced chamber leaking
- Less wasted ink
- Reduced clean-up and associated downtime
- Less chamber pressure needed
- Longer blade life
- Less anilox wear
- Improved print quality.
